Case History
Cocked/Misaligned Sleeve Bearing
Ray Kelm, P.E. Category IV
Kelm Engineering
ray@kelmengineering.com

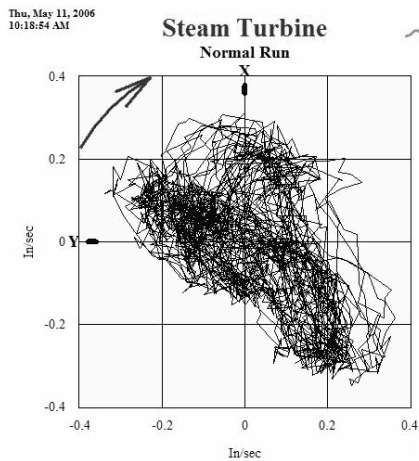
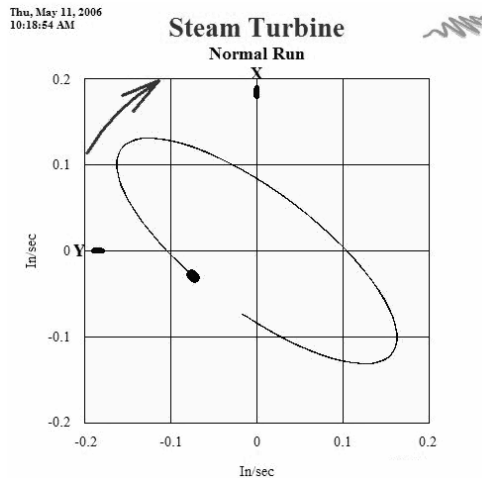
Measured Data: Accelerometers were mounted in the vertical, horizontal and axial positions on each of the bearing housings when this data was captured, with the signals integrated to velocity. The vibration on the turbine outboard was found to have predominant vibration at 1xRPM, with harmonics of running speed as shown in the attached FFT plots. The same data was displayed as raw orbits and orbits filtered at 1xRPM.

Analysis: The data indicated that the vertical and horizontal readings were pretty much in phase, with indications of a “preloaded” orbit that is typical of restricted motion in one direction.. This along with the presence of harmonic vibration 2x, 3x, 4x, etc. suggested that the outboard bearing liner may be cocked or not parallel with the journal. The drive end bearing also showed about 0.2 in/sec, with the vibration primarily at 1xRPM, but with the vertical and horizontal about 90° different phase.

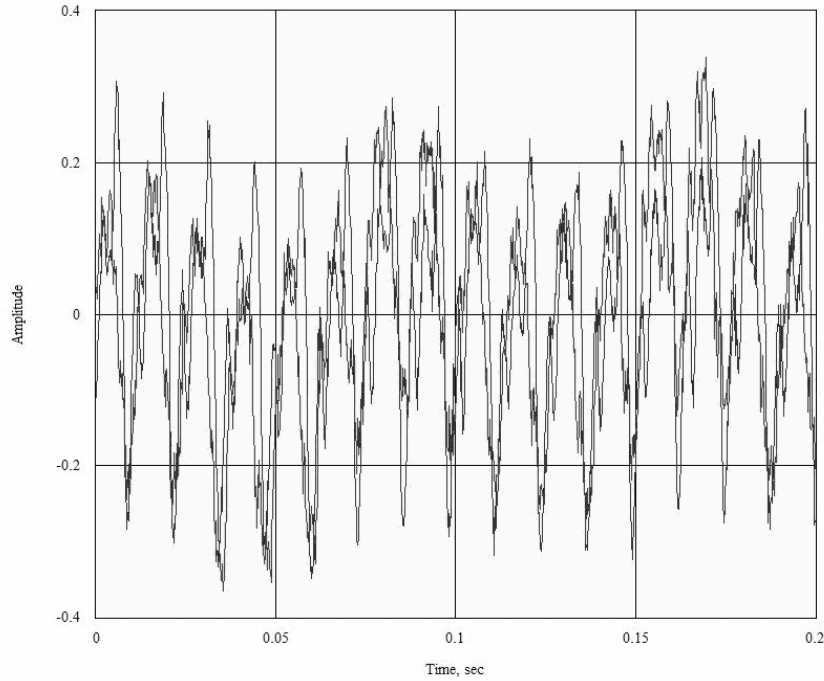
Steam Turbine Normal Run

Findings: Conversation with the mechanical contacts in the plant indicated that they had a lot of trouble installing and aligning the outboard bearing to the journal. Their comments strongly supported the likelihood that the bearing liner was not properly aligned to the journal.
